Experience in Using the Service Manual
on Keel Assembly Renovation by M. Donovan
with Variations for an Earlier Atalanta (A-16)

The methods described by Mr. M. Donovan were followed but some differences were found due to the age of the boat. The equipment was also simplified to make it easier for amateur fabrication.

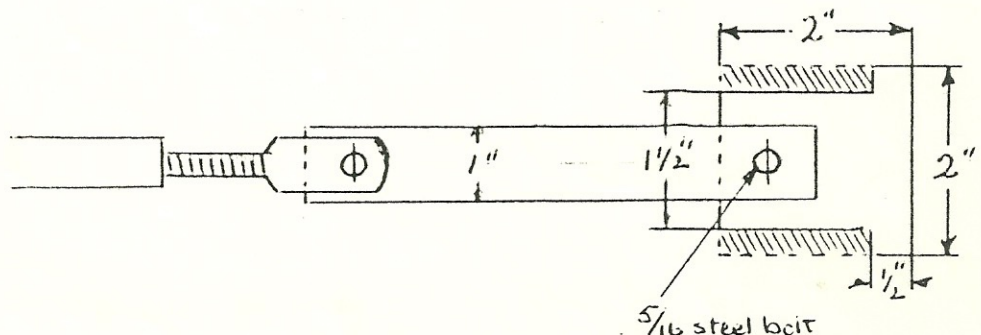
The schematic diagram shows an extractor which was used in the same way as described in Section 4.2(d).

The material required is 1" x 1/8" and 2" x 1/8" mild steel strip. Cut six 2" x 2" squares and shape by cutting away the shaded areas. Bolt to one end of a 1" x 1/8" strip with a 5/16" bolt. Cut the strip to length to suit available bottle screws. Fork ends can be fitted using the clevis pins, but shackles must be used for bottle screws with eyes.
