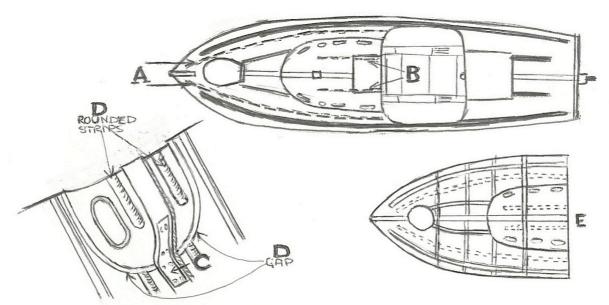
**BACKING STRIPS (E)**

THERE WERE NO BACKING STRIPS UNDER THE DECK STRIPS MARKED WITH A DOTTED LINE (A), OR UNDER THE HATCH RUNNERS ON THE BLISTER MARKED WITH A DOTTED LINE (B), ON ATALANTA A95.

VIEW LOOKING UP UNDER BLISTER SHOWS ALLOY STRIP (C) DOTTED LINES SHOW POSITION OF ROUNDED BACKING STRIPS AND GAP ROUND BLISTER (D).

All paint was removed from the deck-head and an extra layer of laminate or ply was bonded into each section between the support beams. These additional layers were extended round the curved tumblehome. Where the deckhead meets the blister, it is advisable to leave a gap of 3/8", to enable access to the screws that hold the blister. As there were no backing supports under the long deck strips that extend from the bows to the cockpit A, or under the hatch slides on the blister B, these were added. Rounded supports were used on the inside of the blister, extending into the main cabin and being faded into the downward curve of the blister. (Rounded supports were decided for these additions to match the style of the blister). It appeared that there was a weakness where the forward section of the blister met the deck, a strip of alloy, the same width as the centre beam on the inside of the blister, was bent and screwed on C. In the rear cabin some extra beams were placed and two support props added. One about 18" from the transom (size 11A" x 'A"), hinged to the hog and fitting into a wooden gate on the centre deckhead beam with a sliding catch. The second one (11/2" square), fits into a wooden gate on the deckhead centre beam, just aft of the hatch. This support has a sliding bolt at the bottom, which bolts into a hole in the hog.
