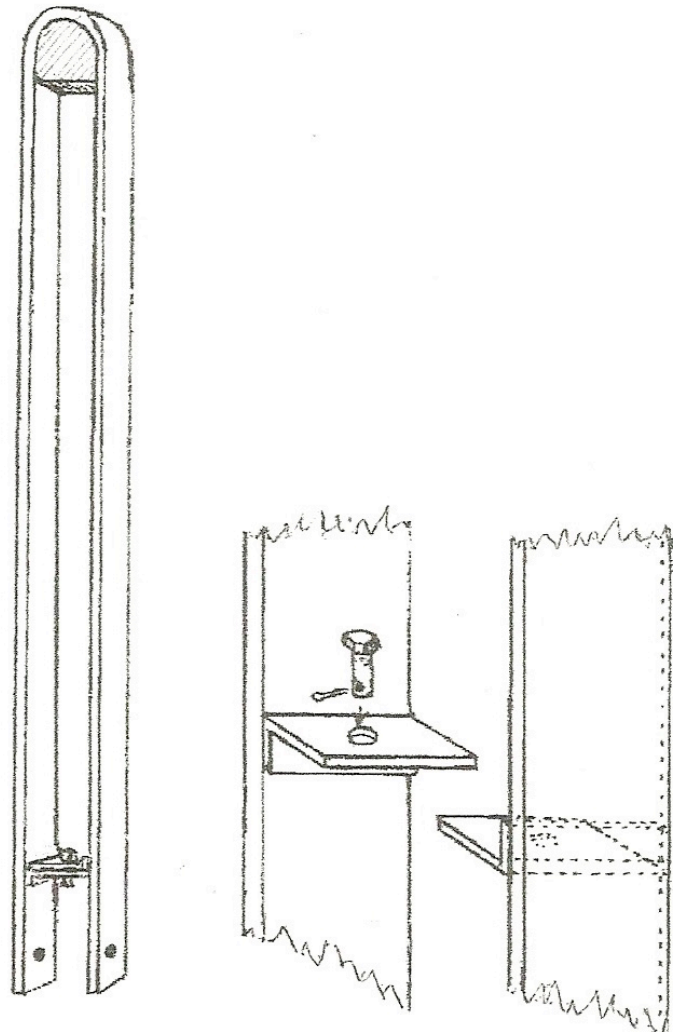
The lifting stirrup that rides the traveller on the worm drive of the keel lifting mechanism is attached to the keel by slipping the arms over the pins attached to the top of the keel. To prevent the pins coming out of the holes, the stirrup is kept together by a nut and bolt. As the keel is lowered and lifted the protruding head of the bolt and the nut frequently scores the inside of the keel box.

A spacing bar is welded to each side of the stirrups in the same location as the holding bolt. A hole is drilled through both of them to receive a stainless bolt or pin. When the stirrup has been located on the keel pins, the bolt or pin is dropped through them and a split pin will secure it in position.

I hope that the illustration is self explanatory.

This method has been fitted to HIRAN for the past ten years and it has proved much easier to remove the pin, than undoing the nut in its fairly inaccessible position when taking the keels out for inspection or renovation,

There has not been any damage to the inside of the keel box since I fitted these spacing bars. Previously the damage had been considerable.
