## "Helene", Fairey Marine Atalanta 26 Lying Essex

Report of a condition survey carried out on the  
Auxiliary Bermudian Sloop

**Helene**

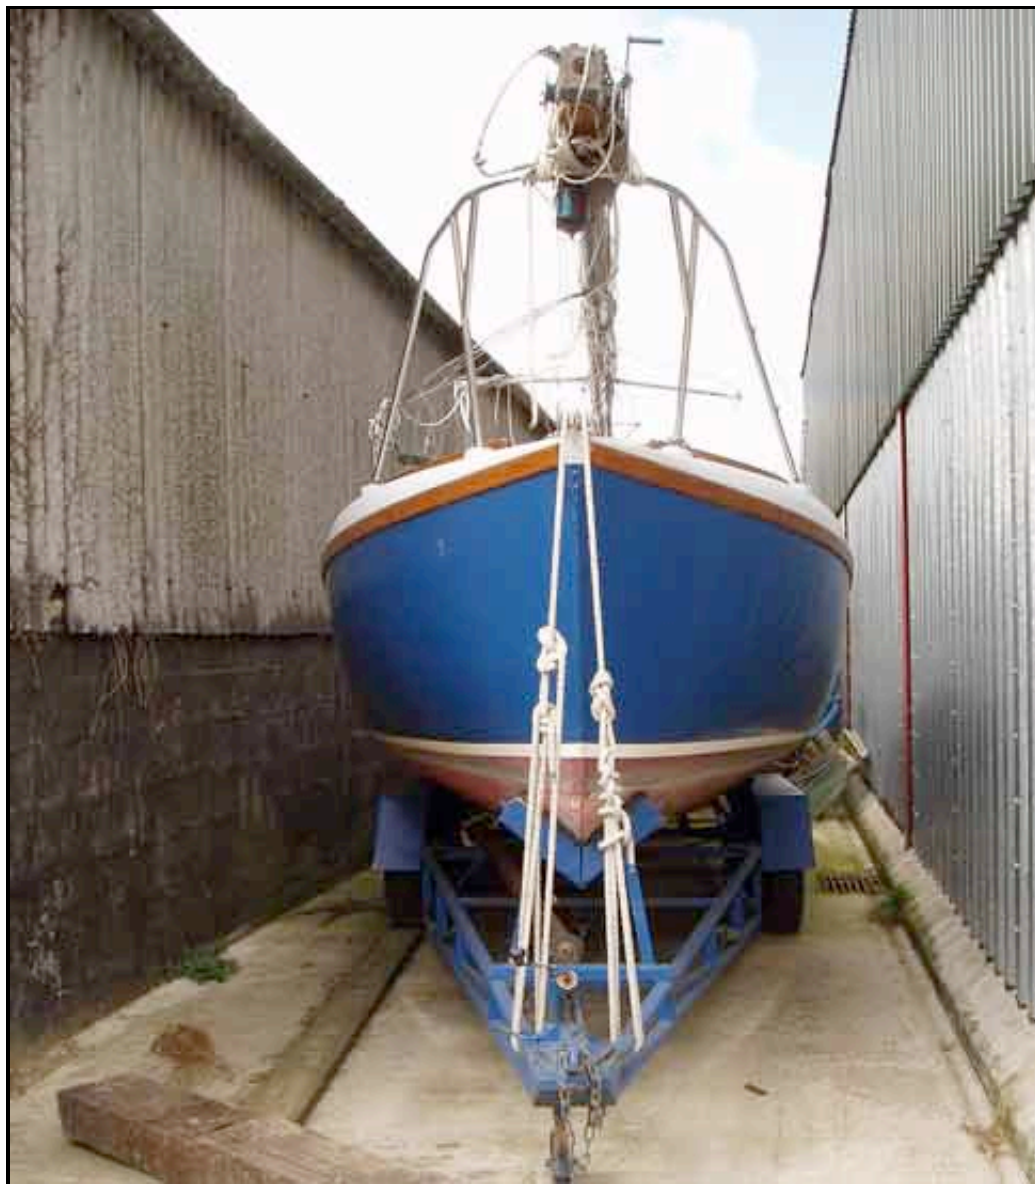
Helene is a Fairey Atalanta designed by Uffa Fox and built by Fairey Marine in 1960. Construction of hull and superstructure is hot moulded Agba. Windows are Perspex.

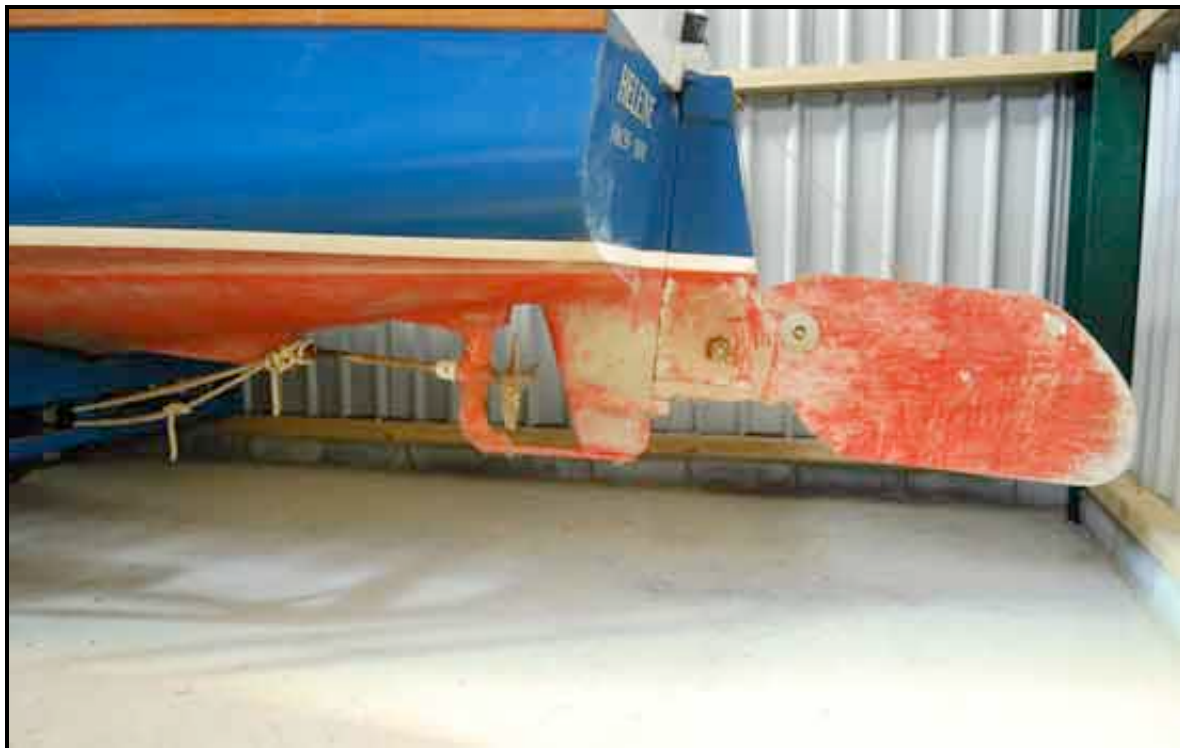
She has twin swing ballast keels and a self draining cockpit.

Twin lifting cast iron keels fitted inside plywood cases and manually operated via substantial bronze and stainless steel screw mechanisms. The keels are coated with epoxy paint and from a limited inspection the keels are in a satisfactory condition. The forward pivot pins were not inspected but there is no indication of excessive play or wear.

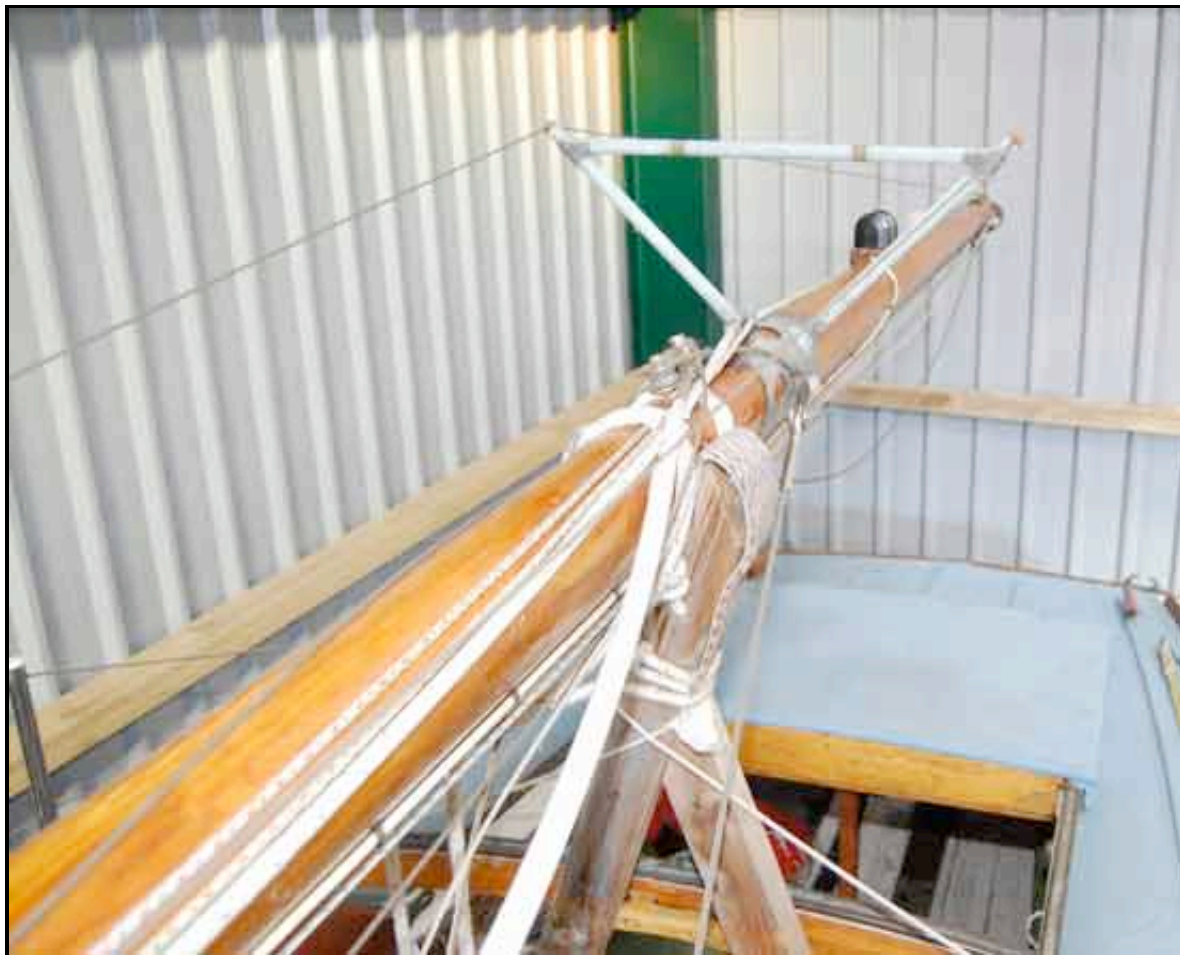
- Bermudan sloop rig

- Wood mast
- Aluminium alloy boom
- Wood boom also available
- Stainless steel standing rigging (1991)
- Mainsail - Jeckells ~2000 - excellent
- Slab reefing on mainsail
- Genoa - Jeckells ~2000 - excellent
- Jib - Jeckells ~2000 - excellent
- Storm jib - probably original
- Sheet winches - new 2000

Varnished laminated spruce mast. The mast is deck stepped with single spreaders and a jumper strut and is fractional rigged. Support is provided via a stainless steel compression post fitted between the hog and cabin roof.
