INTRODUCTION

Martin Bennett A16 DERVORGUILLA
JAN 1990

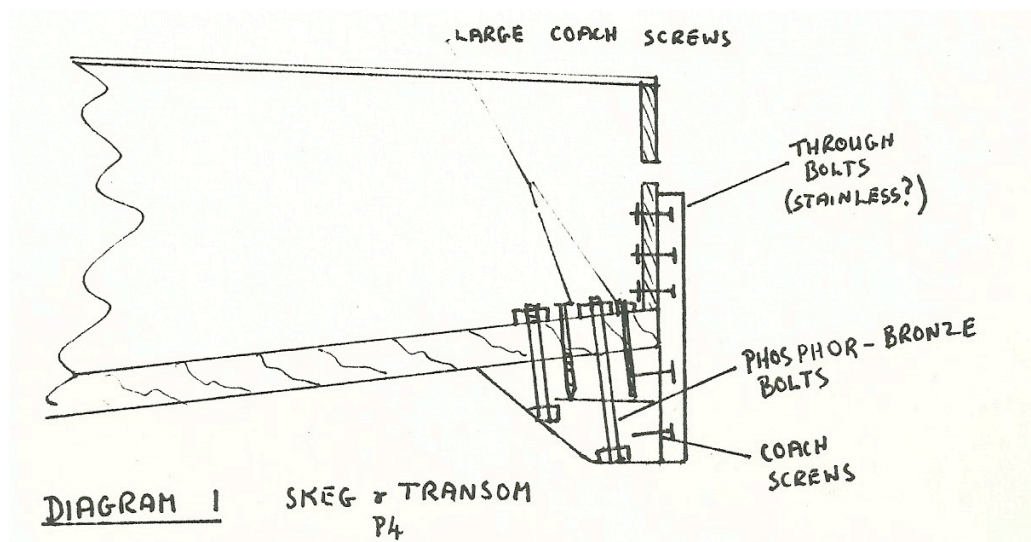
When I came to inspect mine I found that in addition to the coach screws there were two very long 5/8" Phosphor_Bronze bolts through the hug and skeg. This seems to be a very good design, enabling the skeg to be tightened if it works loose. I would strongly recommend this modification to anyone. < Thank you Aubtiu (Clarlance) Farrar, who put my boat together in 1956) These bolts were made with 5/6" rod with a die run down each end. If I could not obtain Phosphor Bronze I would use 316 stainless bar in preference to galvanised mild steel, and would use a protective grease [see diagram) Again a time consuming but inexpensive operation.
