POSSIBLE REASON WHY OLD. BADLY CORRODED KEEL BOLTS (ie. bottom bolts) MAY BE DIFFICULT TO REMOVE

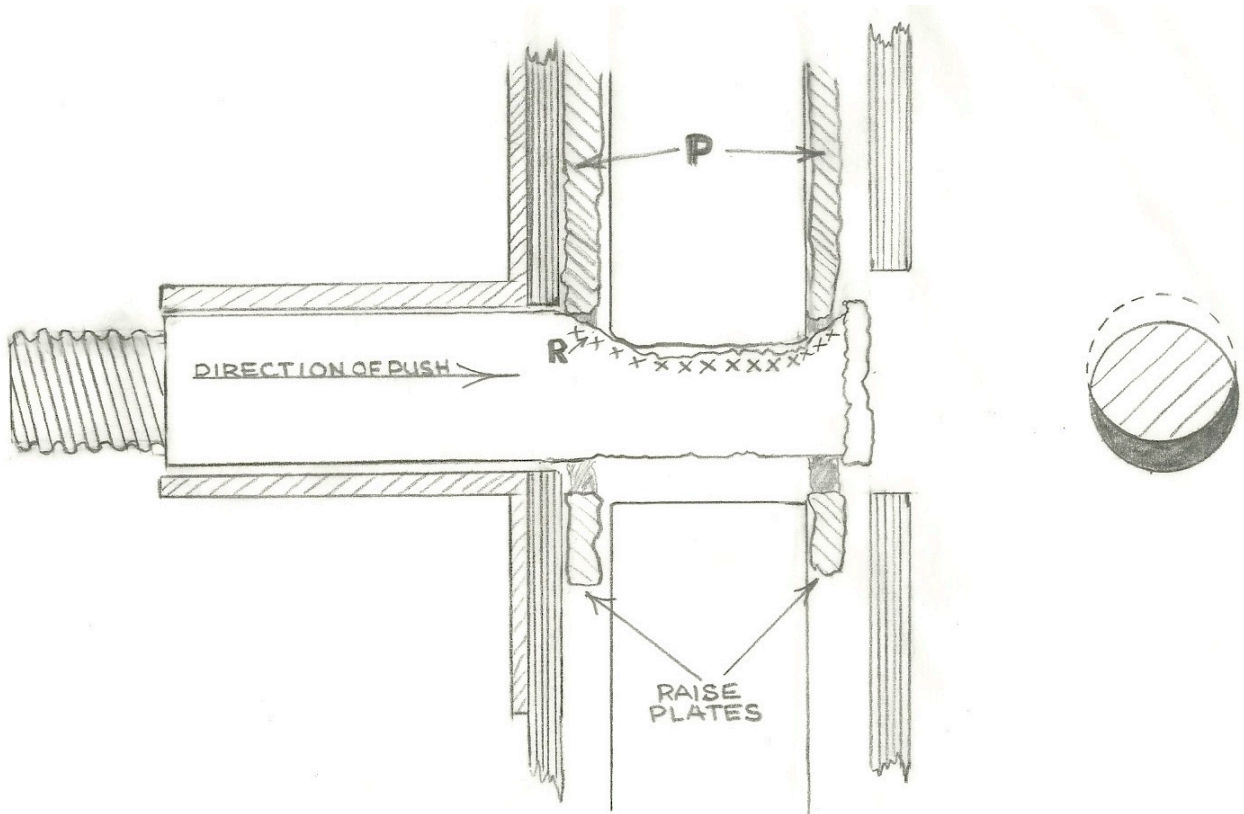
Severe corrosion on top face of the lower (pivoting) keel bolts marked below allows keels to settle down into worn saddle on top of keel bolts.

Pushing keel bolts causes the ridge "R" around the top of keel bolts to foul against the pivoting holes through the keels, preventing further movement.

Jack up keels to restore them to the original line with keel bolts and resume pushing, this may require some manipulation to obtain correct alignment.

If still reluctant, check that the pressure plates "P" have not also dropped into saddles. If they have push them up in line with keel bolts.
