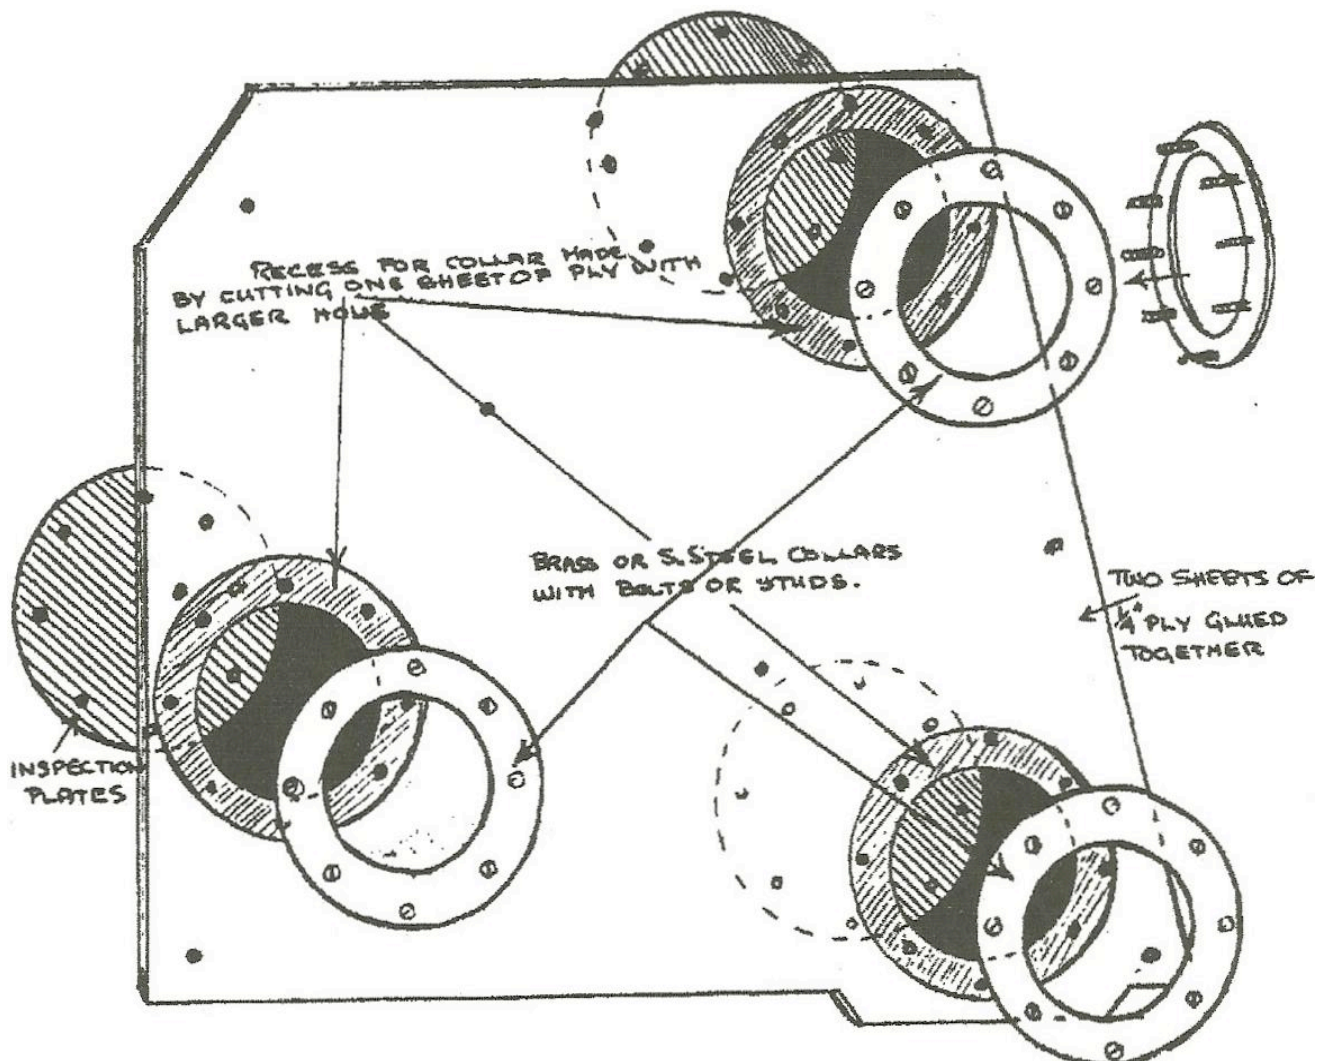
The constant removal of the Keel Bolt inspection plates has caused considerable damage to the plywood outer sides of the Keel Boxes. Filling and relocating of the screws was only a temporary solution, so I offer this more permanent idea.

- Remove the support for the bunk headboards and make a template of the outer side of each Keel Box, marking the Bolt access holes.
- Using this template, mark out on 1/4" Marine Ply two panels for each side.
- Cut out the Bolt apertures on one panel and mark the screw holes, using the existing Plates as templates, round the apertures.
- Then insert stainless steel or bronze bolts size M4 with either washers, or as I used, a brass collar.
- The 2nd panel of ply was cut out round the collars and stuck to the 1st with S.P. or W.E.S.T. This double panel was attached with S.P. and screws to the Keel Box.
- The circular inspection plates are held on with winged nuts and the usual sealer; they are easily removed and replaced without damage to the wood.
- The Bunk supports were replaced and the headboard adjusted.
- UPDATED NOVEMBER 2007
